Manhole Inspection Summary

Manhole # S19C1_004MH

Insp Date: **5/19/08 9:15 AM**

Location Address: **2047 deering av**

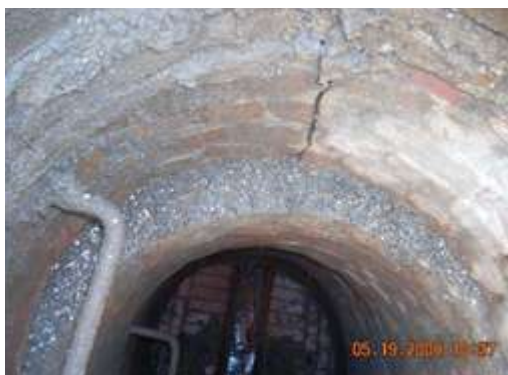
misc

corbel brick offset

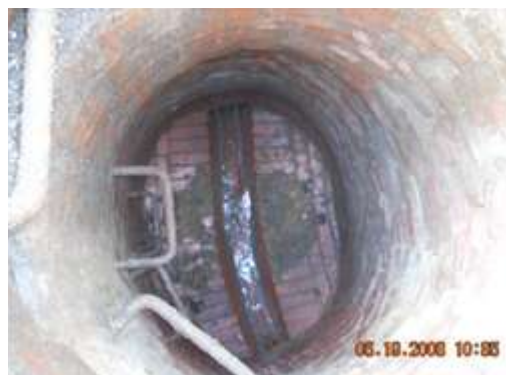
misc

bench debris

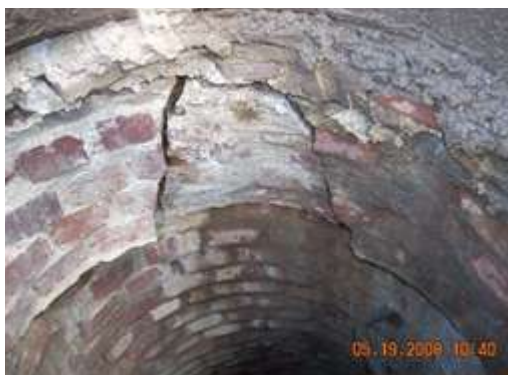
Defect 6

Condition: ☐ Sound ☒ **Cracked** ☐ Root Intrusion ☐ Loose Brick ☐ Deteriorated

fractured corbel bricks

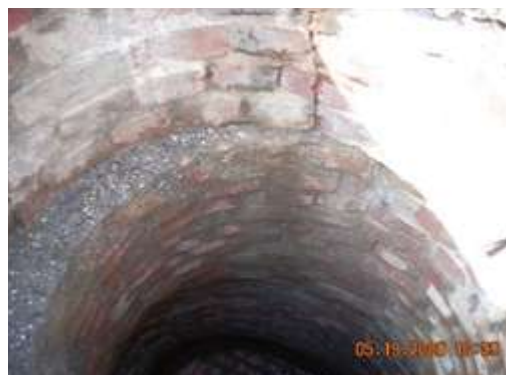
Defect 5

Infiltration: ☐ None ☒ **Joint** ☐ Cracks ☐ Mortar ☐ Roots ☐ Wall

infiltration from corbel joint/offset

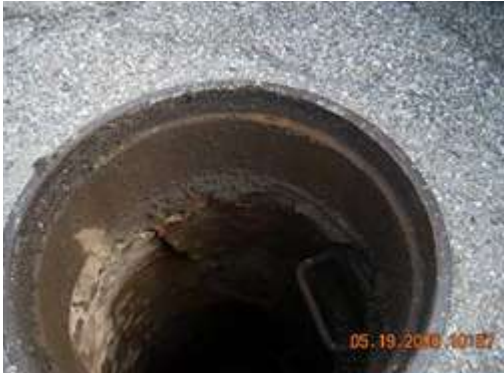
Defect 3

Subject To Ponding: **Sheeting**

Infiltration: ☐ None ☒ **Joint** ☐ Cracks ☐ Mortar ☐ Roots ☐ Wall

inflow evidence from sheeting, infiltration
@ chimney joint

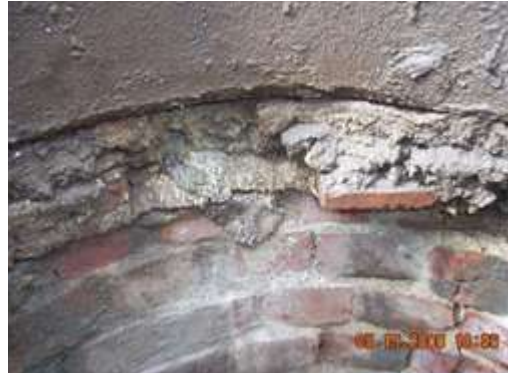
Defect 2

Condition: ☐ Sound ☐ Cracked ☐ Root Intrusion ☐ Loose Brick ☒ **Deteriorated**

deteriorated chimney

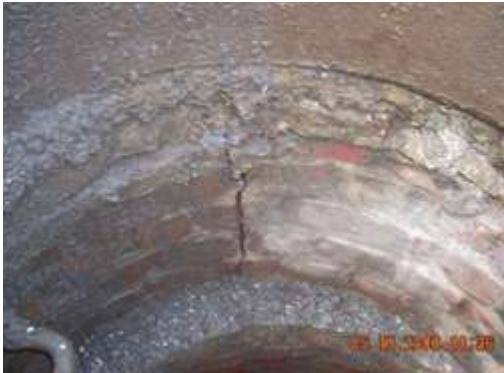
Defect 1

Frame Offset: **0** (in.) Condition: ☐ Sound ☐ Cracked ☒ **Leaks**

frame leaks, cracked corbel bricks

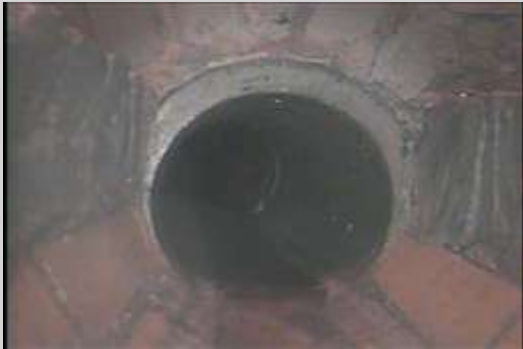
12 O'Clock Outflow

Infiltration: **None** Pipe Seal Cond: **Sound**

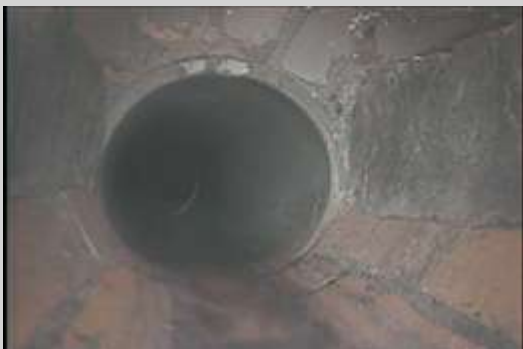
5 O'Clock Inflow

Infiltration: **None** Pipe Seal Cond: **Sound**
